SCUBAPRO®

#274

Engineering Bulletin

MK25 adjustment: minor improvement

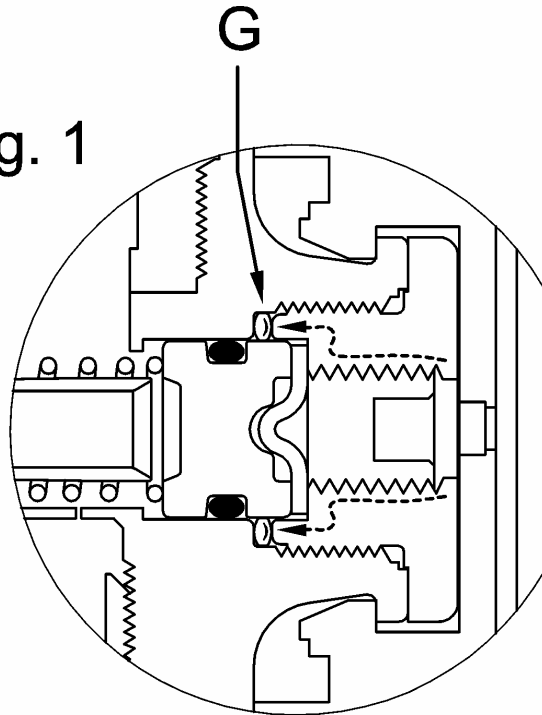
Fig. 1

This modification is meant to address the remote possibility of water drops entering through the threads between the seat retainer and the adjustment screw and thus, in the case of the MK25UL only, to form some oxidation (figure 1). For consistency, the change is extended to the entire line. With the new parts, o-ring (O) and washer (W) (fig. 2), the area in question is sealed and dry.
